Water Penetration Testing of an Adhered Masonry Veneer Wall Assembly

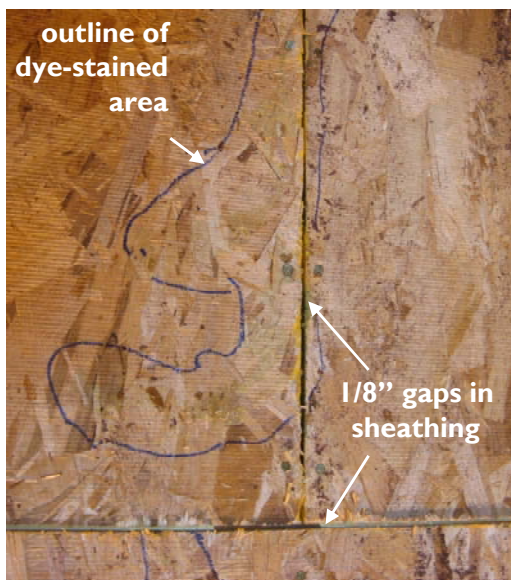
Test Result: Within minutes of initiating the test, water was observed pooling around the horizontal seam in the OSB and spilled over into a stud cavity on both assemblies. Green dye was subsequently added to the water to aid in identification of the leak source. The lath and layers of WRB were systematically removed from the test wall. It was concluded that water ran through the WRB at the lath fasteners along the vertical seams in the sheathing (Fig. 7). The vertical seams in the sheathing coincide with the framing members (Fig. 1), which are also the lath fastening locations. This common field scenario co-locates penetrations in the WRB with a direct path to the interior wall cavity, creating an opportunity for water to penetrate. No water penetration was observed at lath fastening locations that did not coincide with a sheathing gap.

Fig. 7 – Photo of sheathing after water penetration test with WRB & lath only.
